SKANEATELES LAKE AND WATERSHED 2021 ANNUAL REPORT VOLUME XLVII

DEPARTMENT OF WATER

CITY OF SYRACUSE
DEPARTMENT OF WATER
WATER QUALITY MANAGEMENT

SKANEATELES LAKE AND WATERSHED
2021 ANNUAL REPORT

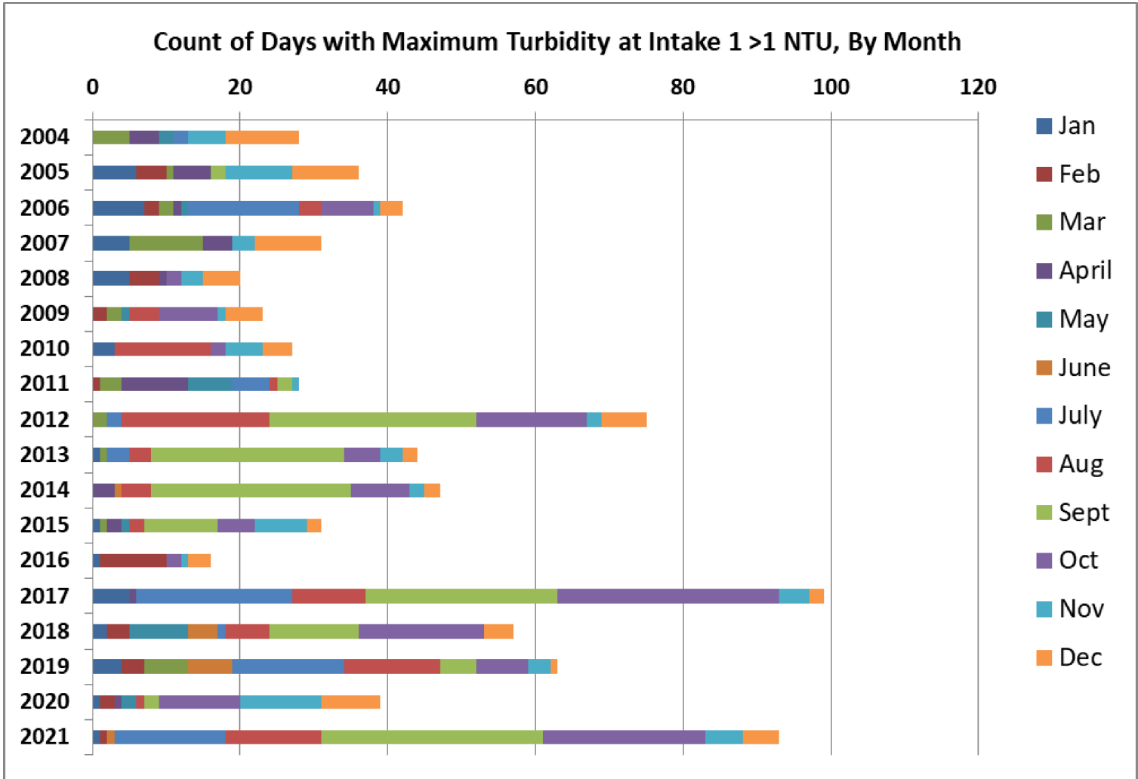
Figure 4 Monthly Counts of Turbidity >1 NTU at Intake 1, 2004-2021

Both Table No. 9 and Figure 4 display the variance in the number of days with maximum turbidity greater than 1 NTU at Intake #1 from 2004 to 2021.

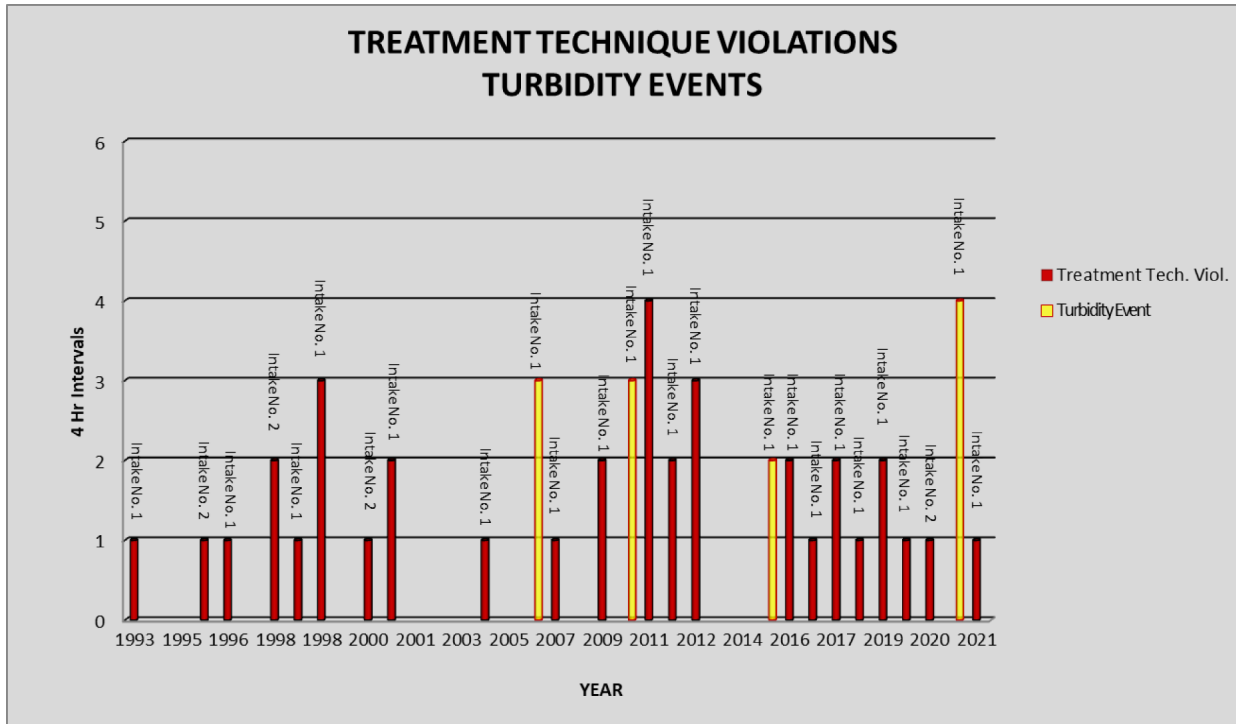
Figure 5 1993-2021 Treatment Technique Violations vs Turbidity Events

Refer to Figure 5 for TTV and Turbidity Events recorded since 1993. The Graph also displays the frequency that 5.0 NTU was exceeded (on a four hour interval) during the TTV or Turbidity Event. Note that in 2015, a Turbidity Event consisted of only two 5.0 NTU exceedances at four hour intervals, comparable to numerous TTV's illustrated in the graph. However, because the intervals were at 8:00 pm and 12:00 am, the conditions set forth by NYSDOH defining a Turbidity Event (a series of consecutive days during which at least one turbidity measurement each day exceeded 5 NTU) was attained.

One TTV was recorded in 2021. The violation occurred on November 12, on Intake #1. Sustained southerly winds resulted in an elevated turbidity recording of 10.73 NTU at 12:00 am. Intake #2 was completely closed by 11:20 pm on November 11 and re-opened on November 14. There were no Turbidity Events in 2021.

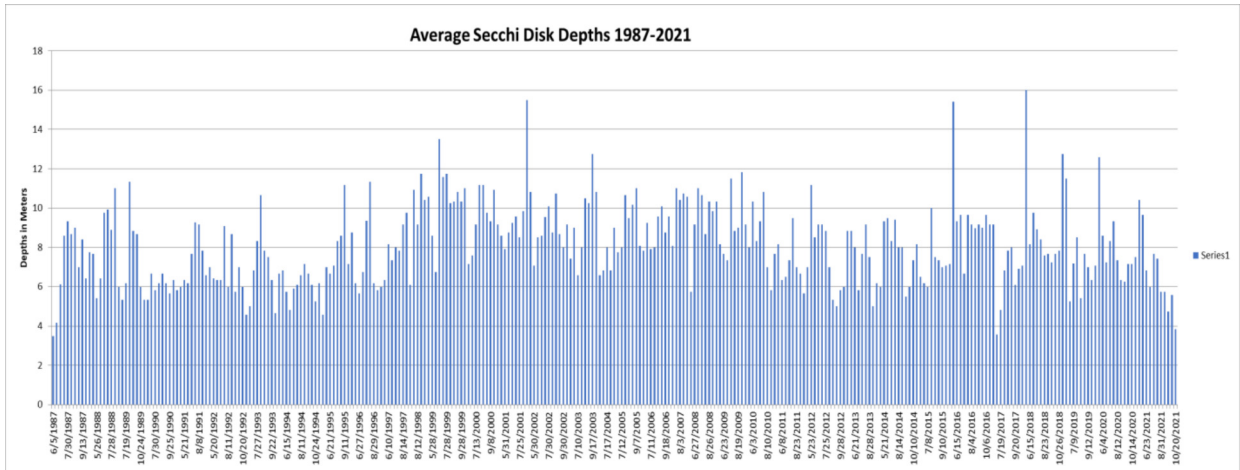
Figure 6 Average Secchi Disk Depths 1987-2021

It is noted that the Secchi disk readings effected during the station sampling can be somewhat skewed. Since stations I and VIII are shallow, the readings are consistently at the bottom, which is usually about six meters (as a result, samples are collected at about 15 feet). It is not unusual for the readings at the other Stations to vary considerably throughout the spring, summer and fall seasons, ranging from four to 16 meters (Figure 6). Figures 7 and 8 illustrate Secchi disk depth variations between early summer and fall. References to Secchi disk readings in the narrative below are adjusted, i.e., only Stations II – VII were used to determine averages.

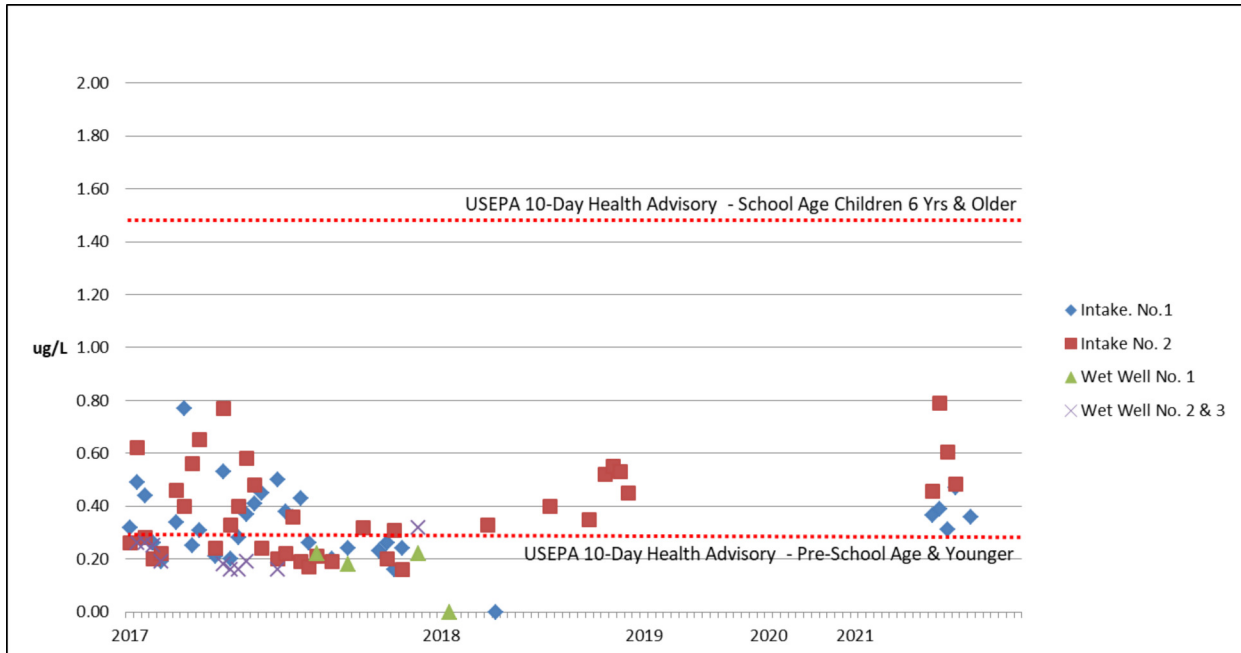
Figure 9 Skaneateles Lake Microcystin Levels 2017-2021

Throughout periods of microcystin detections in raw water intakes (2017, 2018 & 2021), the City has demonstrated that by boosting chlorine levels at the water intake cribs and wet wells and maintaining an elevated chlorine concentration in finished water, microcystin detection within the water distribution system could be avoided. Figure No. 9 shows the number of microcystin detections for both raw and treated water samples and the range of detections for the previous four years. Note that microcystin was not detected in 2019 or 2020.

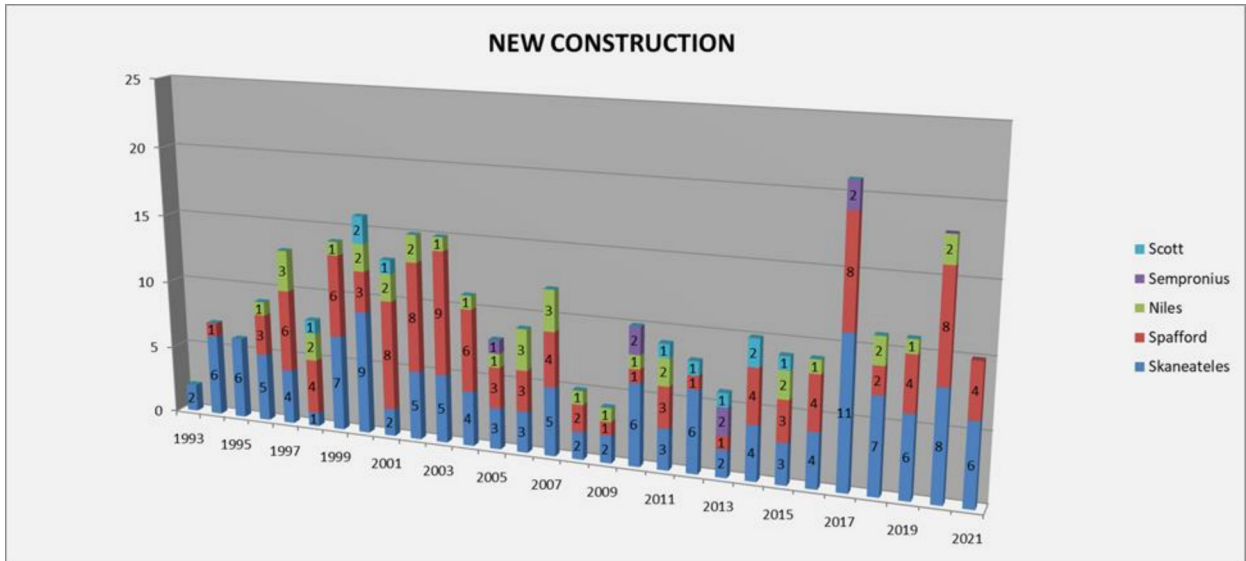
Figure 11 New Construction Activity within the Skaneateles Lake Watershed 1993-2021

The Watershed Protection Program reviewed a total 80 Building and Zoning Permit Applications in 2021. As discussed above, 10 were new construction. Twenty six applications were additions or renovations to existing dwellings and the remaining 44 applications included shoreline structures, accessory structures, landscape features or proposed subdivisions and lot line relocations. Figures 11 through 14 illustrate new construction and renovation proposals reviewed by the City of Syracuse and monitored throughout project duration in the Skaneateles Lake Watershed since 1993.

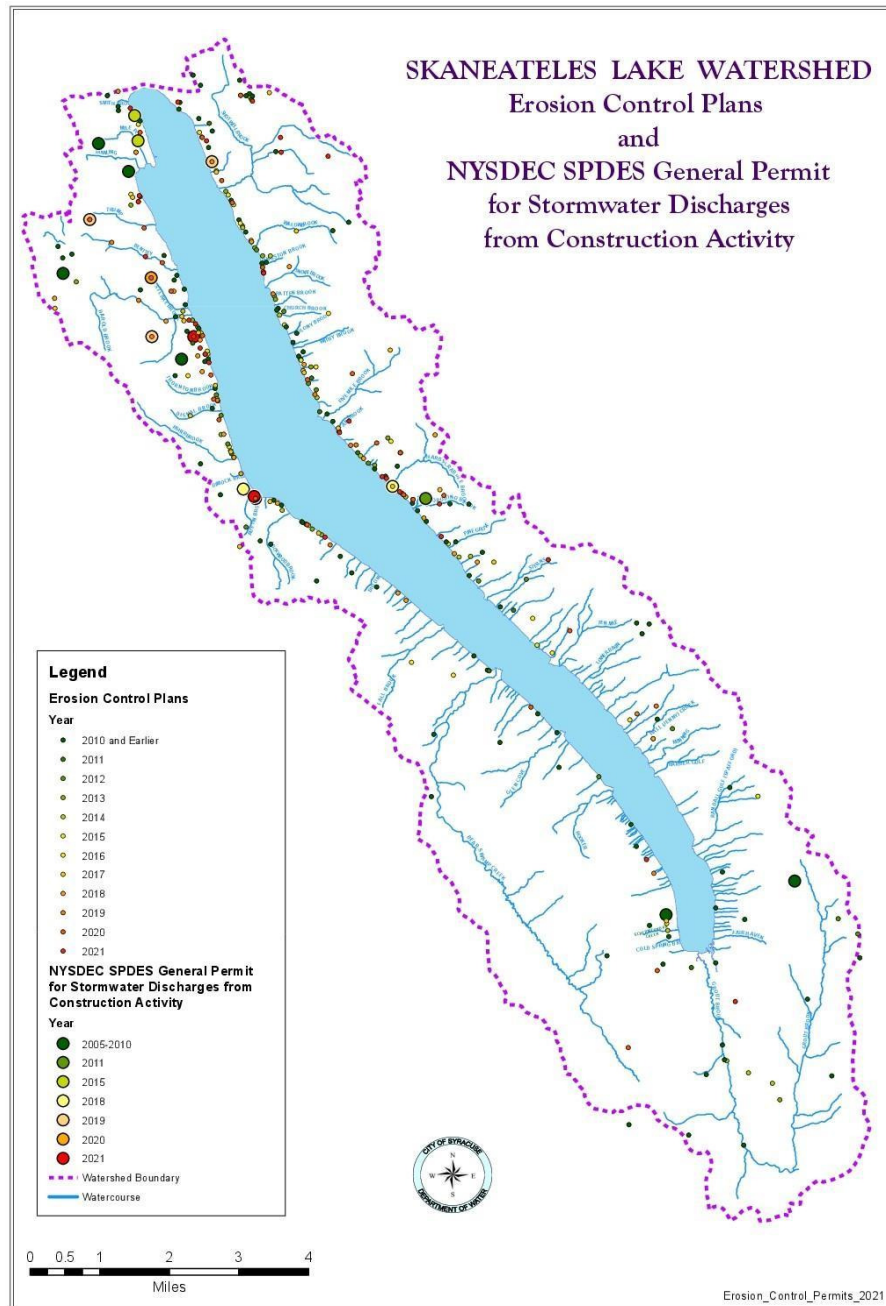
Figure 15 Erosion Control Plans/NYSDEC SPDES Permits

As of 2004, the Skaneateles Watershed Rules and Regulations require property owners proposing to disturb 5,000 square feet or greater of land in defined environmentally sensitive areas to submit a Sediment and Erosion Control Plan (SECP) to the City of Syracuse for review. In 2021, 29 SECPs were reviewed. A NYSDEC SPDES General Permit for Storm water Discharges (GP-0-15-002) is required in New York State for all construction activity over one acre. Three permits were issued for construction activity in the Watershed in 2021 under GP-0-15-002. Figure 15 illustrates SECP's reviewed and SPDES General Permits issued within the Skaneateles Lake Watershed since 2004.

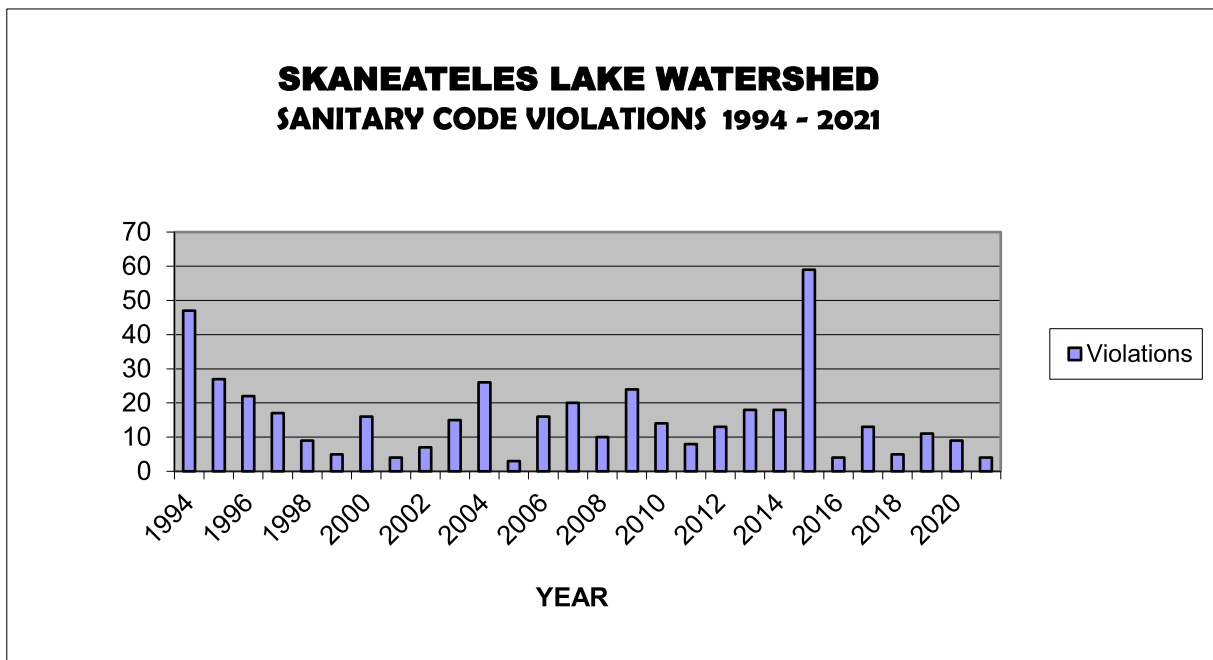
Figure 16 Skaneateles Lake Watershed Sanitary Code Violations 1994-2021

The enforcement of Sanitary Code violations is the responsibility of the respective county health departments. Alleged violators are issued a Violation Notice from the City of Syracuse and given five working days to reply and declare their intent to affect the necessary repairs. If there is no response, or if the property owner refuses to abate the problem, the violation is forwarded to the respective county health department for enforcement. Sanitary Code violations identified by Watershed Inspectors since 1994 are shown in Figure 16.

Four violations of County Sanitary Code were reported in 2021. All violations were the result of failing OWTS. (Table No. 28 at end of next section).
