SKANEATELES LAKE AND WATERSHED 2021 ANNUAL REPORT VOLUME XLVII

DEPARTMENT OF WATER

CITY OF SYRACUSE
DEPARTMENT OF WATER
WATER QUALITY MANAGEMENT

SKANEATELES LAKE AND WATERSHED
2021 ANNUAL REPORT

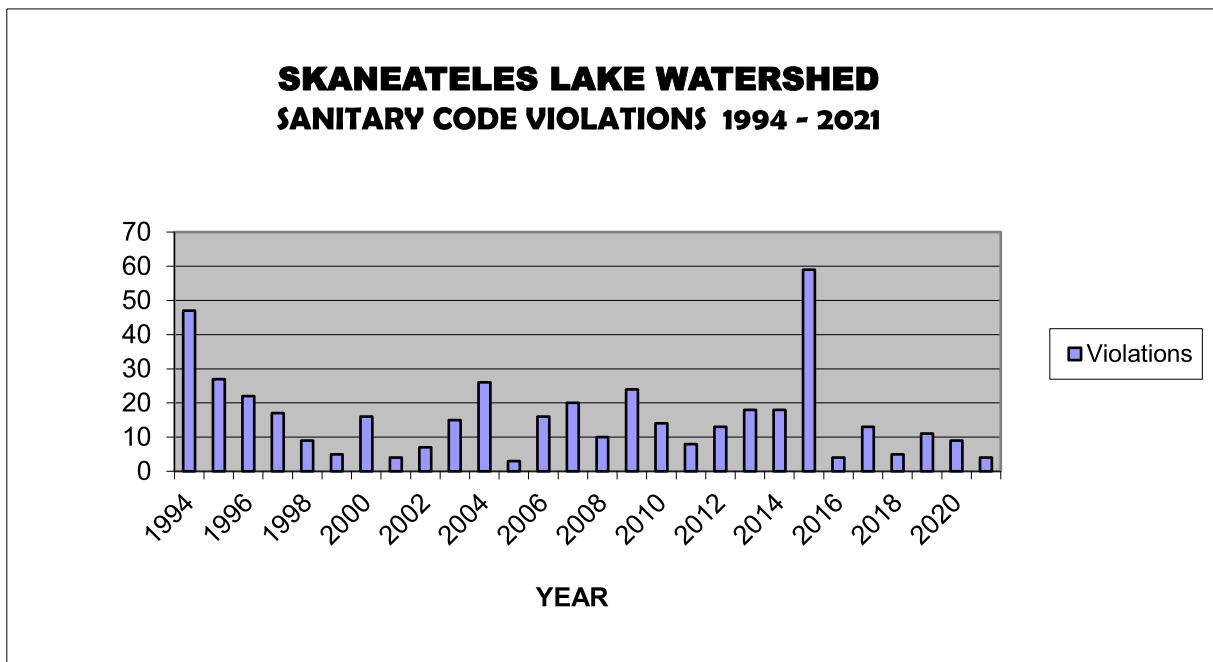
Figure 16 Skaneateles Lake Watershed Sanitary Code Violations 1994-2021

The enforcement of Sanitary Code violations is the responsibility of the respective county health departments. Alleged violators are issued a Violation Notice from the City of Syracuse and given five working days to reply and declare their intent to affect the necessary repairs. If there is no response, or if the property owner refuses to abate the problem, the violation is forwarded to the respective county health department for enforcement. Sanitary Code violations identified by Watershed Inspectors since 1994 are shown in Figure 16.

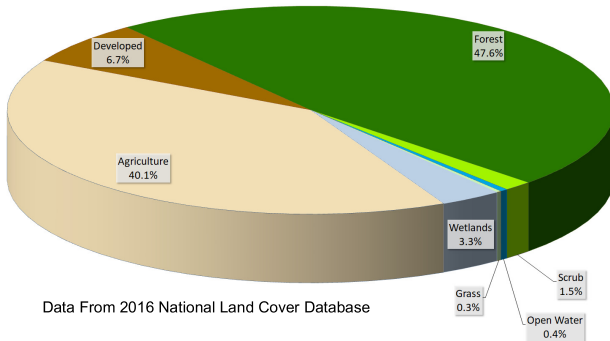
WATERSHED LAND USE PERCENTAGES

Data From 2016 National Land Cover Database
